**Flood Control Project Maintenance  
Levee Inspections**

**Maintenance Issue Types Only, Levee Inspection Report By Mile - Fall 2018**

**Reclamation District No. 0544 Upper Roberts Island**

Waterway	Bank	Unit Miles	Inspection Start/End	Inspector
Unit No. 01 San Joaquin River	Left	6.05	09/13/2018 09/13/2018	Richard Willoughby

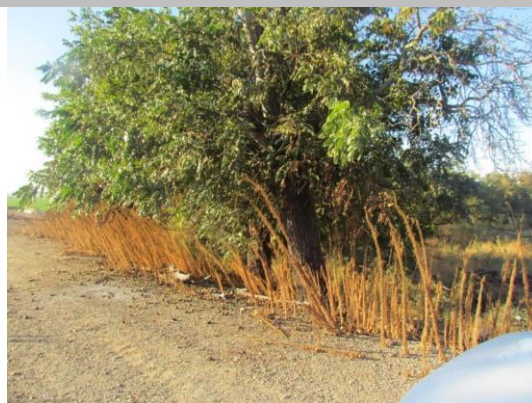
Photo 1 of 1 : FA\_2018\_RD0544\_108\_92\_20180906\_00066.jpg

Looking southwest at untrimmed tree on landward slope.

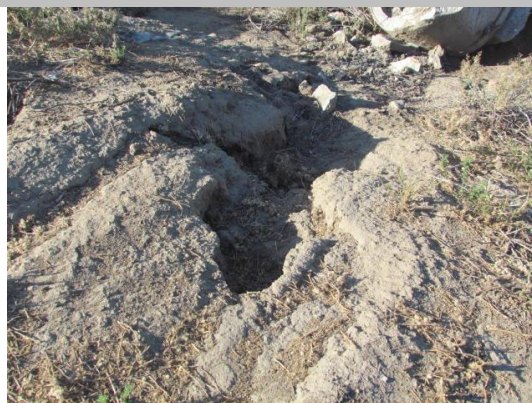
Photo 1 of 1 : FA\_2018\_RD0544\_108\_118\_20180906\_00084.jpg

LM Start	0.06	Rating **	U	Issue No.	118
LM End	0.06	Issue Type +	Ma	Location *	LS
Category	Earthen Levee			GPS Latitude/Longitude	
				Start	End
Item	Erosion / Bank Caving			37.869570 °	37.869570 °
				-121.329556 °	-121.329556 °
DWR ID	DWR_RD0544_01_f_2015_118				
Comment Code					
E2 : Schedule repair of erosion site prior to the next inspection.					
Inspector Comment					
Finger erosion noted on landside slope.

Looking west at landside erosion for shoulder to middle of levee slope.

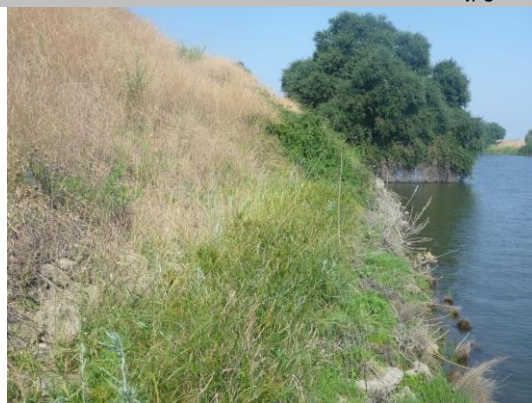
Photo 1 of 3 : LEVAL\_FA\_2018\_571\_4478.jpg

LM Start	0.64	Rating **	A/W	Issue No.	75
LM End	0.64	Issue Type +	Ma	Location *	
Category	Supplemental			GPS Latitude/Longitude	
				Start	End
Item	2017 Storm Damage			37.863900 °	37.863900 °
				-121.323500 °	-121.323400 °
DWR ID	DWR_RD0544_01_f _ 2017_75				
Comment Code					
Inspector Comment					
Levee Evaluation Comments					
Description:Slope protection repairs are needed along the waterside slope due to erosion and riprap displacement from high water. Based upon levee inspections, it was determined the waterside levee slope is eroding, deteriorating, and degrading. The eroded levee sections need to be restored back to design standards to prevent further deterioration and damage.					
Site ID No:571					
Site Designation:LMA-477					
Repair Type: Erosion					
Rating:Area of Concern					
Field Date:8/10/2017					
Notes:

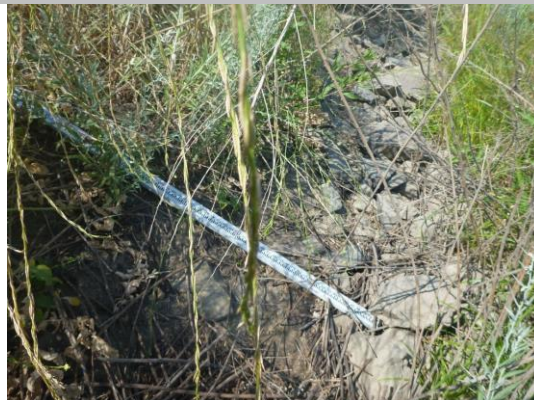
Photo 1 of 3 : LEVAL\_FA\_2018\_570\_4597.jpg

LM Start	0.99	Rating **	A/W	Issue No.	77
LM End	1.02	Issue Type +	Ma	Location *	
Category	Supplemental			GPS Latitude/Longitude	
				Start	End
Item	2017 Storm Damage			37.860400 °	37.860200 °
				-121.320300 °	-121.319700 °
DWR ID	DWR_RD0544_01_f_2017_77				
Comment Code					
Inspector Comment					
Levee Evaluation Comments					
Description:Slope protection repairs are needed along the waterside slope due to erosion and riprap displacement from high water. Based upon levee inspections, it was determined the waterside levee slope is eroding, deteriorating, and degrading. The eroded levee sections need to be restored back to design standards to prevent further deterioration and damage.					
Site ID No:570					
Site Designation:LMA-476					
Repair Type: Erosion					
Rating:Area of Concern					
Field Date:8/10/2017					
Notes:

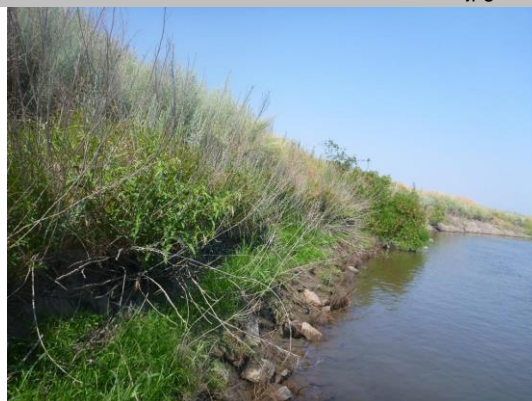
Photo 3 of 3 : LEVAL\_FA\_2018\_570\_4602.jpg

LM Start	0.99	Rating **	A/W	Issue No.	77 (cont)
LM End	1.02	Issue Type +	Ma	Location *	
Category	Supplemental			GPS Latitude/Longitude	
				Start	End
Item	2017 Storm Damage			37.860400 °	37.860200 °
				-121.320300 °	-121.319700 °
DWR ID	DWR_RD0544_01_f_2017_77				
Comment Code					
Inspector Comment					
Levee Evaluation Comments					
Description:Slope protection repairs are needed along the waterside slope due to erosion and riprap displacement from high water. Based upon levee inspections, it was determined the waterside levee slope is eroding, deteriorating, and degrading. The eroded levee sections need to be restored back to design standards to prevent further deterioration and damage.					
Site ID No:570					
Site Designation:LMA-476					
Repair Type: Erosion					
Rating:Area of Concern					
Field Date:8/10/2017					
Notes:

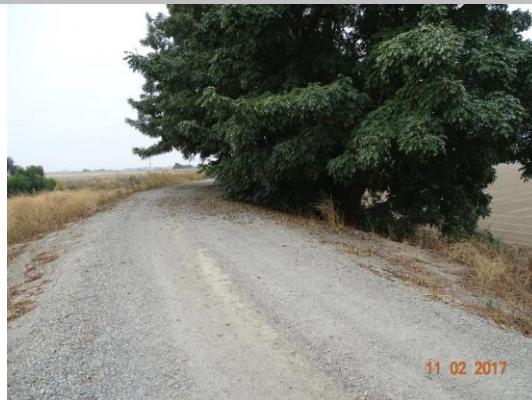
Photo 1 of 2 : FA\_2018\_RD0544\_108\_39\_20180906\_00031.jpg

LM Start	1.12	Rating **	M	Issue No.	39
LM End	1.12	Issue Type +	Ma	Location *	LS
Category	Earthen Levee			GPS Latitude/Longitude	
				Start	End
Item	Trim / Thin Trees			37.859423 °	37.859423 °
				-121.318328 °	-121.318328 °
DWR ID	DWR_RD0544_01_s_2012_39				
Comment Code					
T1 : Trim trees to at least five feet above ground level.					
Inspector Comment					
Untrimmed trees on landside slope.

Looking southwest at landside slope.

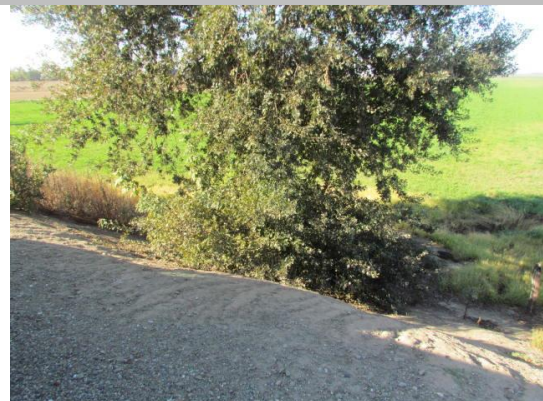
Photo 1 of 1 : FA\_2018\_RD0544\_108\_87\_20180906\_00062.jpg

Looking west at untrimmed tree at landward toe fall 2015.

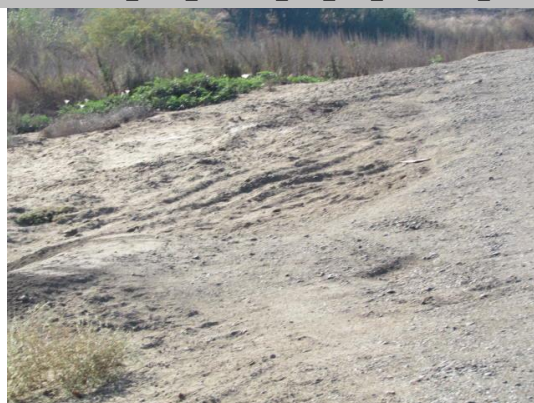
Photo 2 of 3 : FA\_2018\_RD0544\_108\_119\_20180906\_00086.jpg

LM Start	1.50	Rating **	M	Issue No.	119
LM End	1.51	Issue Type +	Ma	Location *	WS
Category	Earthen Levee			GPS Latitude/Longitude	
				Start	End
Item	Slope Stability			37.854844 °	37.854564 °
				-121.321090 °	-121.321031 °
DWR ID	DWR_RD0544_01_f_2015_119				
Comment Code					
S2 : Repair the levee slope damaged by foot traffic and prevent access where possible.					
Inspector Comment					
Damaged levee slope due to fishermen using slope as a ramp.

Looking east at damaged waterward slope fall 2015.

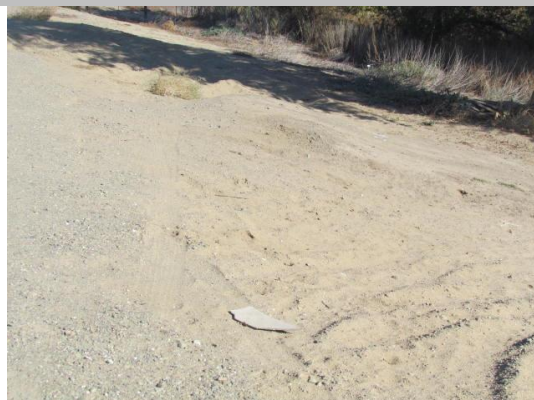
Photo 3 of 3 : FA\_2018\_RD0544\_108\_119\_20180906\_00087.jpg

Looking southeast at damaged waterward slope fall 2015

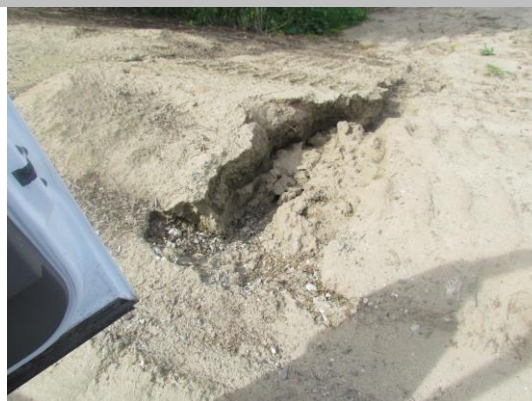
Photo 1 of 2 : FA\_2018\_RD0544\_108\_80\_20180906\_00057.jpg

LM Start	1.82	Rating **	U	Issue No.	80
LM End	1.82	Issue Type +	Ma	Location *	LS
Category	Earthen Levee			GPS Latitude/Longitude	
				Start	End
Item	Erosion / Bank Caving			37.853173 °	37.853173 °
				-121.324145 °	-121.324145 °
DWR ID	DWR_RD0544_01_s_2017_80				
Comment Code					
E2 : Schedule repair of erosion site prior to the next inspection.					
Inspector Comment					
Repair slope damage due to water runoff.

Looking west at slope damage due to rain runoff on waterward slope.

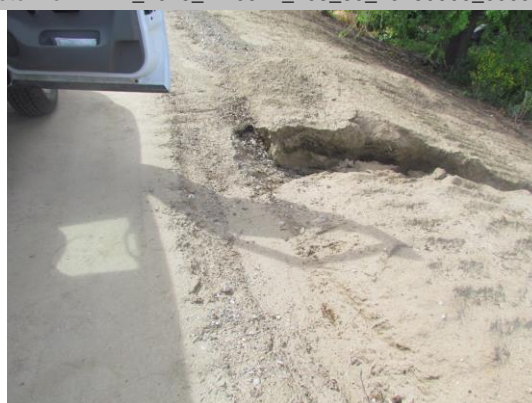
Photo 2 of 2 : FA\_2018\_RD0544\_108\_80\_20180906\_00058.jpg

Looking south at slope damage due to rain runoff on waterward slope.

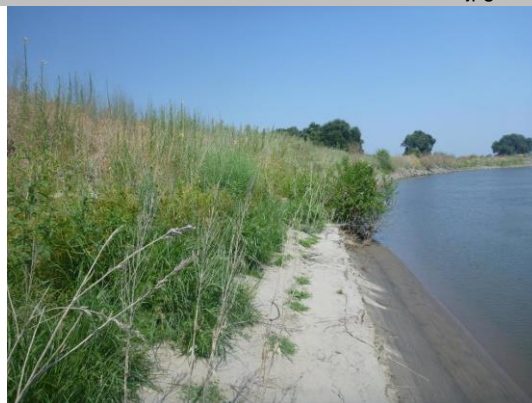
Photo 2 of 3 : LEVAL\_FA\_2018\_569\_4615.jpg

Description: Slope protection repairs are needed along the waterside slope due to erosion and riprap displacement from high water. Based upon levee inspections, it was determined the waterside levee slope is eroding, deteriorating, and degrading. The eroded levee sections need to be restored back to design standards to prevent further deterioration and damage.

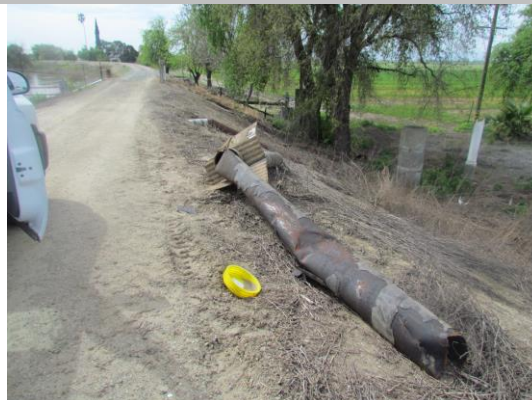
Photo 1 of 1 : FA\_2018\_RD0544\_108\_82\_20180906\_00059.jpg

Looking southwest at old irrigation pipe on landward shoulder.

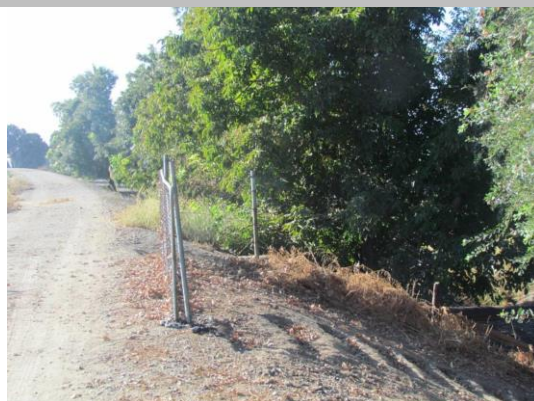
Photo 1 of 1 : FA\_2018\_RD0544\_108\_98\_20180906\_00069.jpg

Looking south at untrimmed trees on landward slope.

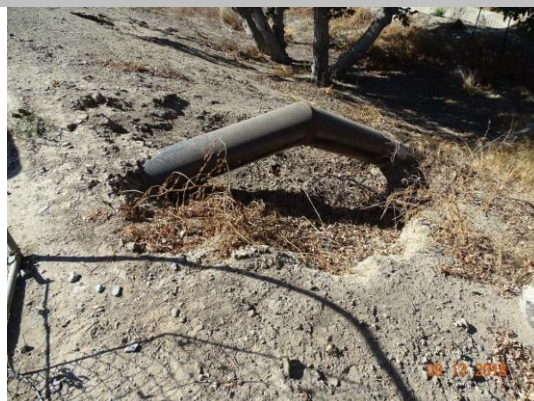
Photo 1 of 3 : FA\_2018\_RD0544\_108\_44\_20180919\_00175.jpg

LM Start	2.27	Rating **	U	Issue No.	44
LM End	2.27	Issue Type +	Ma	Location *	LS
Category	Earthen Levee			GPS Latitude/Longitude	
				Start	End
Item	Erosion / Bank Caving			37.847990 °	37.847990 °
				-121.324897 °	-121.324897 °
DWR ID	DWR_RD0544_01_f_2018_44				
Comment Code					
E2 : Schedule repair of erosion site prior to the next inspection.					
Inspector Comment					
erosion around irrigation pipe on landward slope.

Looking southwest at erosion around irrigation pipe on landward slope.  
(Fall 2018)

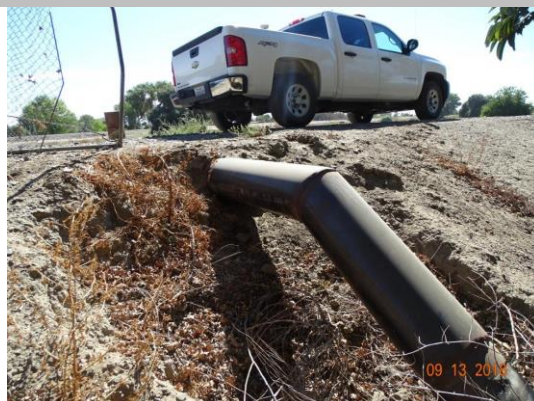
Photo 3 of 3 : FA\_2018\_RD0544\_108\_44\_20180919\_00176.jpg

LM Start	2.27	Rating **	U	Issue No.	44 (cont)	
LM End	2.27	Issue Type +	Ma	Location *	LS	
Category	Earthen Levee			GPS Latitude/Longitude		
				Start		End
Item	Erosion / Bank Caving			37.847990 °		37.847990 °
				-121.324897 °		-121.324897 °
DWR ID	DWR_RD0544_01_f_2018_44					
Comment Code						
E2 : Schedule repair of erosion site prior to the next inspection.						
Inspector Comment						
erosion around irrigation pipe on landward slope.

Looking east at erosion around pipe. (Fall 2018)

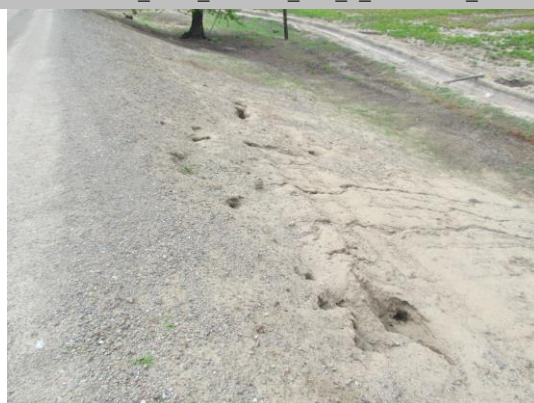
Photo 1 of 1 : FA\_2018\_RD0544\_108\_8\_20180906\_00013.jpg

Looking southwest at several rodent holes on landward shoulder and slope.

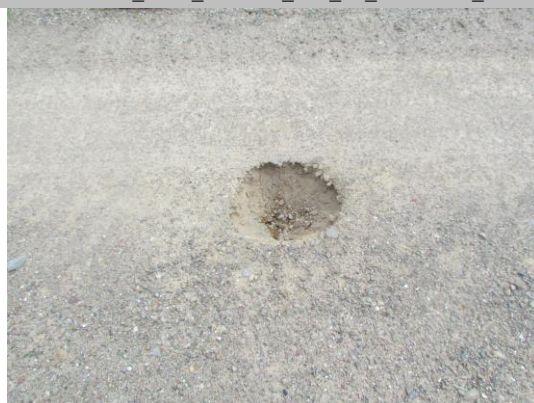
Photo 1 of 1 : FA\_2018\_RD0544\_108\_90\_20180906\_00064.jpg

LM Start	2.30	Rating **	A/W	Issue No.	90
LM End	2.30	Issue Type +	Ma	Location *	CR
Category	Earthen Levee			GPS Latitude/Longitude	
				Start	End
Item	Crown Surface / Depressions / Rutting			37.847542 °	37.847542 °
				-121.324732 °	-121.324732 °
DWR ID	DWR_RD0544_01_s_2017_90				
Comment Code					
C2 : Repair depressions or ruts in the crown or slope.					
Inspector Comment					
Sinkhole forming in crown.

Looking at sinkhole on levee crown.

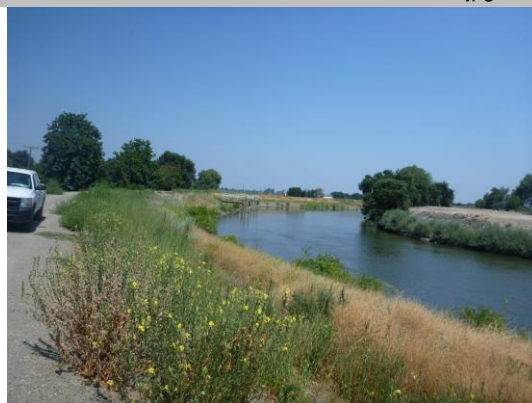
Photo 1 of 3 : LEVAL\_FA\_2018\_568\_4540.jpg

LM Start	2.31	Rating **	A/W	Issue No.	128
LM End	2.35	Issue Type +	Ma	Location *	
Category	Supplemental			GPS Latitude/Longitude	
				Start	End
Item	2017 Storm Damage			37.847300 °	37.846800 °
				-121.324700 °	-121.324400 °
DWR ID	DWR_RD0544_01_f_2017_128				
Comment Code					
Inspector Comment					
Levee Evaluation Comments					
Description:Slope protection repairs are needed along the waterside slope due to erosion and riprap displacement from high water. Based upon levee inspections, it was determined the waterside levee slope is eroding, deteriorating, and degrading. The eroded levee sections need to be restored back to design standards to prevent further deterioration and damage.					
Site ID No:568					
Site Designation:LMA-474					
Repair Type: Erosion					
Rating:Area of Concern					
Field Date:8/10/2017					
Notes:

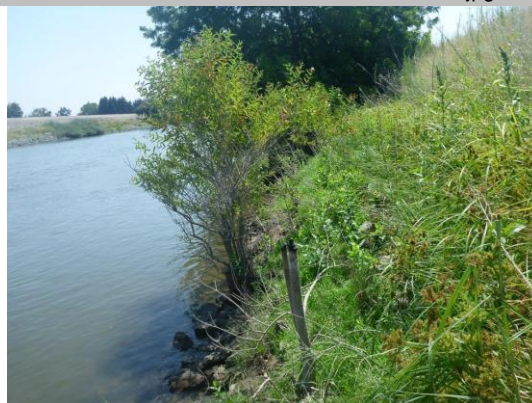
Photo 3 of 3 : LEVAL\_FA\_2018\_568\_4547.jpg

Description: Slope protection repairs are needed along the waterside slope due to erosion and riprap displacement from high water. Based upon levee inspections, it was determined the waterside levee slope is eroding, deteriorating, and degrading. The eroded levee sections need to be restored back to design standards to prevent further deterioration and damage.

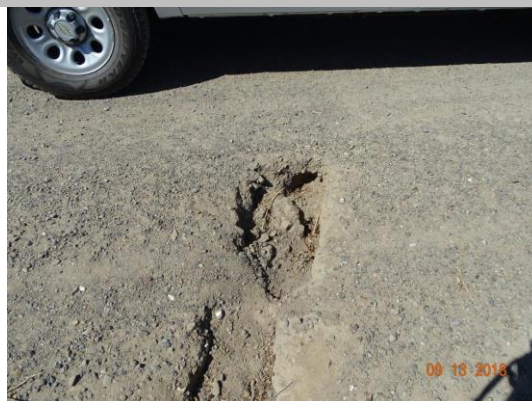
Photo 1 of 1 : FA\_2018\_RD0544\_108\_46\_20180919\_00177.jpg

Looking east at caving on waterward should and slope. (Fall 2018)

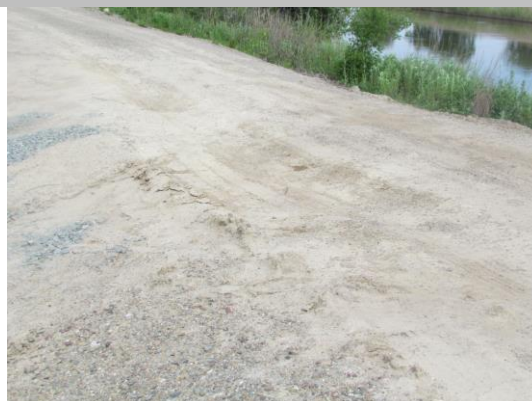
Photo 1 of 1 : FA\_2018\_RD0544\_108\_91\_20180906\_00065.jpg

LM Start	2.43	Rating **	U	Issue No.	91
LM End	2.43	Issue Type +	Ma	Location *	LS
Category	Earthen Levee			GPS Latitude/Longitude	
				Start	End
Item	Slope Stability			37.845973 °	37.845973 °
				-121.323373 °	-121.323373 °
DWR ID	DWR_RD0544_01_s_2017_91				
Comment Code					
S3 : Repair the levee slope damaged by vehicle traffic and prevent access where possible.					
Inspector Comment					
Slope stability with depression in crown due to vehicle traffic.

Looking south at depression on levee crown and landward slope.

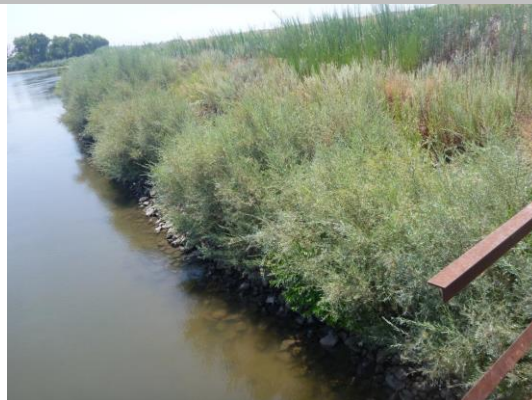
Photo 3 of 3 : LEVAL\_FA\_2018\_567\_4556.jpg

LM Start	2.53	Rating **	A/W	Issue No.	129 (cont)
LM End	2.56	Issue Type +	Ma	Location *	
Category	Supplemental			GPS Latitude/Longitude	
				Start	End
Item	2017 Storm Damage			37.844900 °	37.844500 °
				-121.322300 °	-121.321900 °
DWR ID	DWR_RD0544_01_f _ 2017_129				
Comment Code					
Inspector Comment					
Levee Evaluation Comments					
Description:Slope protection repairs are needed along the waterside slope due to erosion and riprap displacement from high water. Based upon levee inspections, it was determined the waterside levee slope is eroding, deteriorating, and degrading. The eroded levee sections need to be restored back to design standards to prevent further deterioration and damage.					
Site ID No:567					
Site Designation:LMA-473					
Repair Type: Erosion					
Rating:Area of Concern					
Field Date:8/10/2017					
Notes: large rodent holes observed on landside slope.

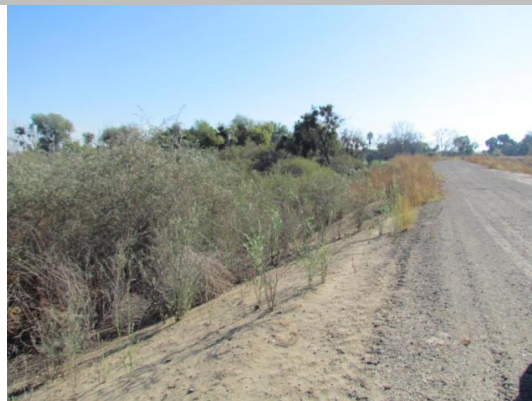
Photo 1 of 1 : FA\_2018\_RD0544\_108\_106\_20180906\_00073.jpg

Looking southeast at dense willows (veg) on waterward slope and toe fall 2015.

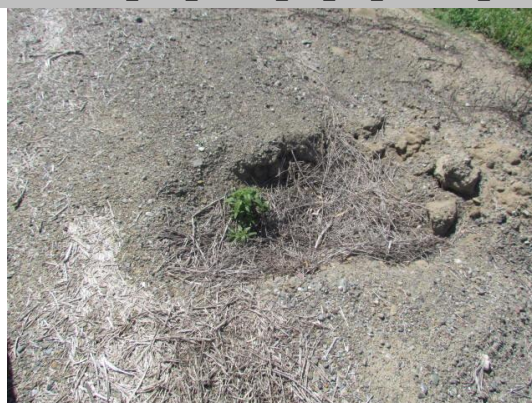
Photo 2 of 2 : FA\_2018\_RD0544\_108\_107\_20180906\_00075.jpg

Looking west at depression on landward shoulder.

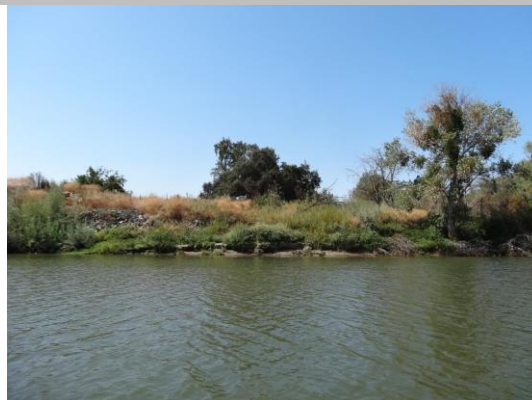
Photo 2 of 3 : FA\_2018\_RD0544\_108\_5\_20180906\_00011.jpg

Front view of the erosion.

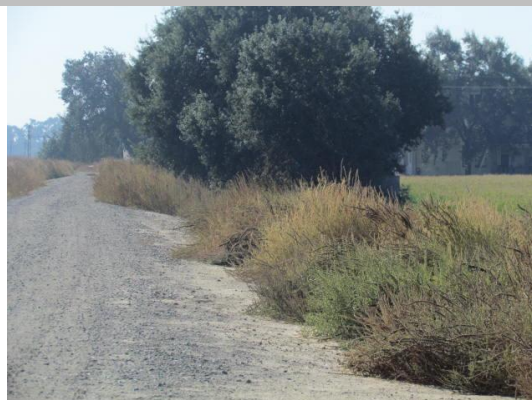
Photo 1 of 1 : FA\_2018\_RD0544\_108\_47\_20180906\_00036.jpg

Looking south at dense veg on landward slope fall 2015.

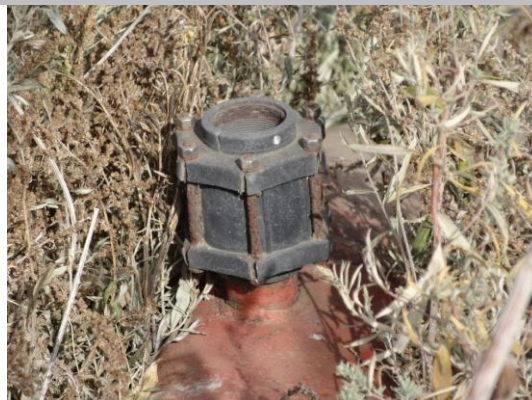
Photo 2 of 3 : UCIP\_FA\_2018\_24892\_44852.jpg

WS view: exposed steel pipe and air vent on the pipe.

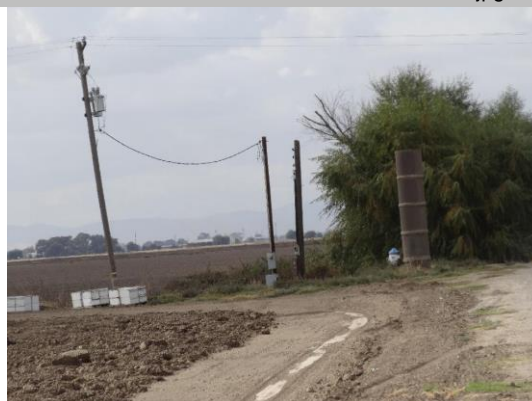
Photo 3 of 3 : UCIP\_FA\_2018\_24892\_44851.jpg

LS view: service pole, pump, and a concrete standpipe on bank of drainage ditch about 500 ft from the levee.

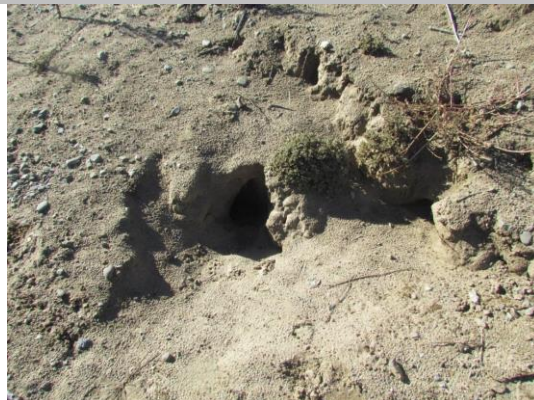
Photo 1 of 1 : FA\_2018\_RD0544\_108\_11\_20180906\_00017.jpg

LM Start	3.92	Rating **	U	Issue No.	11
LM End	4.05	Issue Type +	Ma	Location *	WS
Category	Earthen Levee			GPS Latitude/Longitude	
				Start	End
Item	Animal Control			37.828078 °	37.826315 °
				-121.311483 °	-121.311024 °
DWR ID	DWR_RD0544_01_s_2012_11				
Comment Code					
A1 : Exterminate rodents and backfill and compact or grout burrows.					
Inspector Comment					
Large rodent holes on waterside slope.

Looking at large rodent holes on waterward slope.

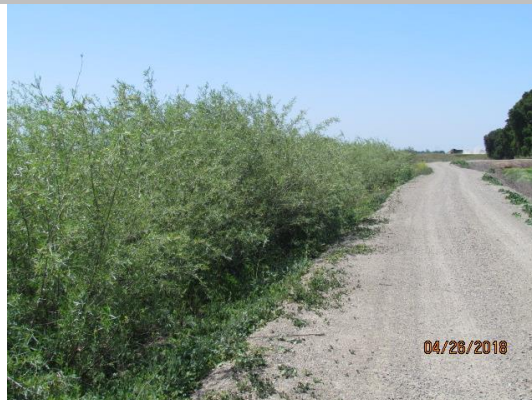
Looking southeast at dense veg on waterward slope. (Spring 2018)

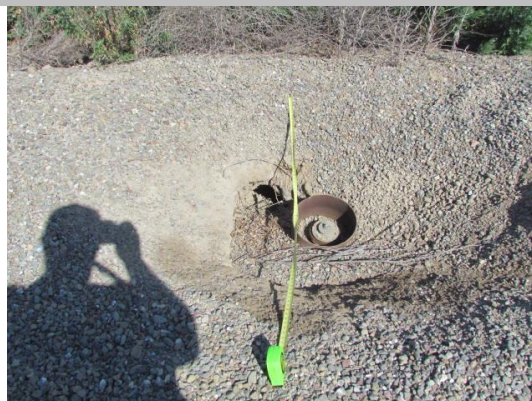
Looking east at caving around siphon on waterside shoulder. (Spring 2012)

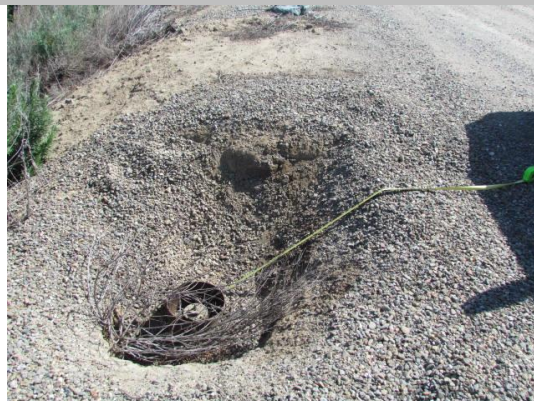
Looking south at caving around siphon on waterside shoulder. (Spring 2012)

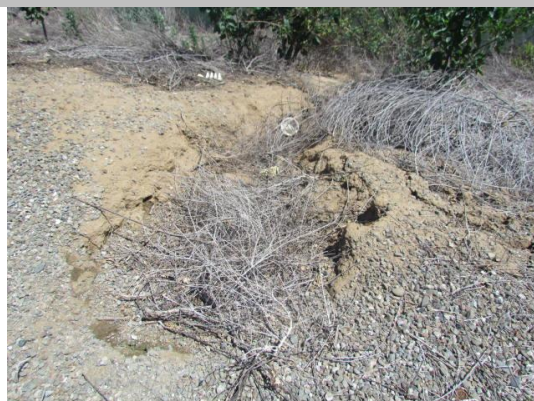
Looking east at erosion/caving on waterward slope.

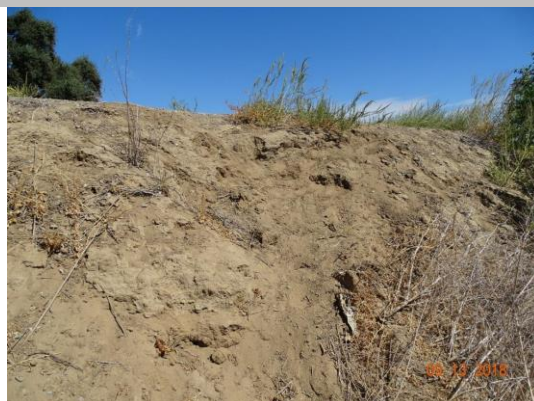
Looking west at erosion on waterward slope. (Fall 2018)

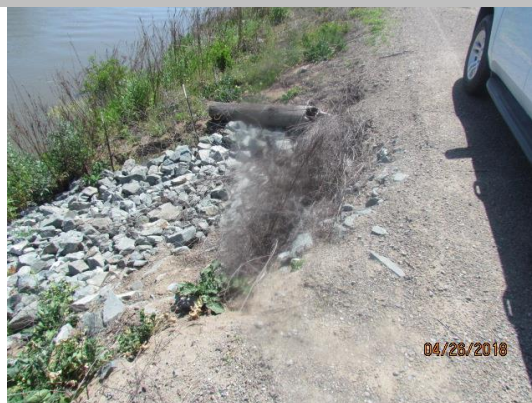
Looking south at erosion on shoulder. (Spring 2018)

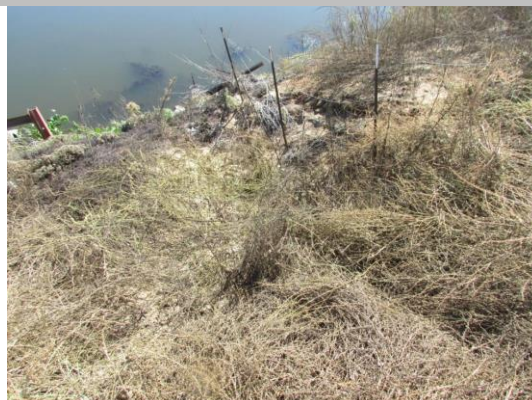
Looking south at waterward erosion.

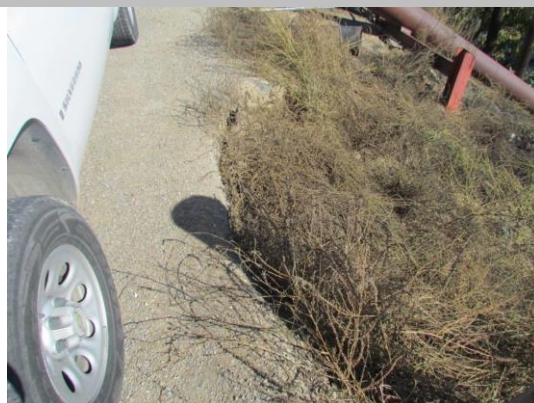
Looking north at erosion on waterward shoulder and slope.

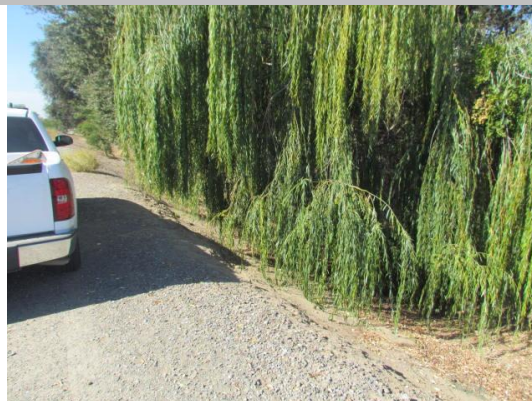
Looking southwest at untrimmed trees on landward slope and toe fall 2015.
